**NUMBER:** 08-003-21

**SUBJECT:**

Improved Steering Feel

| 2018 - 2020 | (JL) | Jeep Wrangler |

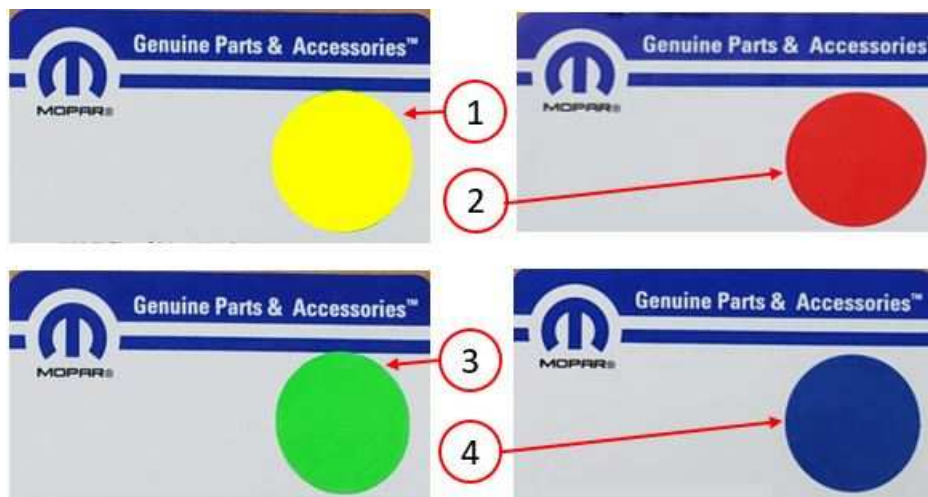
Fig. 1

**The Steering Gear Parts Label Has A Color Dot On It To Help Confirm The Correct Steering Gear Was Ordered**

- 1 - Yellow Dot, 68507576AA (JT Left Hand Drive (LHD))
- 2 - Red Dot, 68507569AA (JL 4 Door LHD, **W/O EXJ 3.0 Diesel**)
- 3 - Green Dot, 68507574AA (JL 4 Door LHD, **With EXJ 3.0 Diesel**)
- 4 - Blue Dot, 68507571AA (JL 2 Door LHD)
