STAR ONLINE PUBLICATION

Case Number: S2208000063 Rev. A

Symptom/Vehicle Issue: Loss Of Power Steering Assist. U0131 Lost Communication With Electro Hydraulic Power Steering Control Module (EHPS).

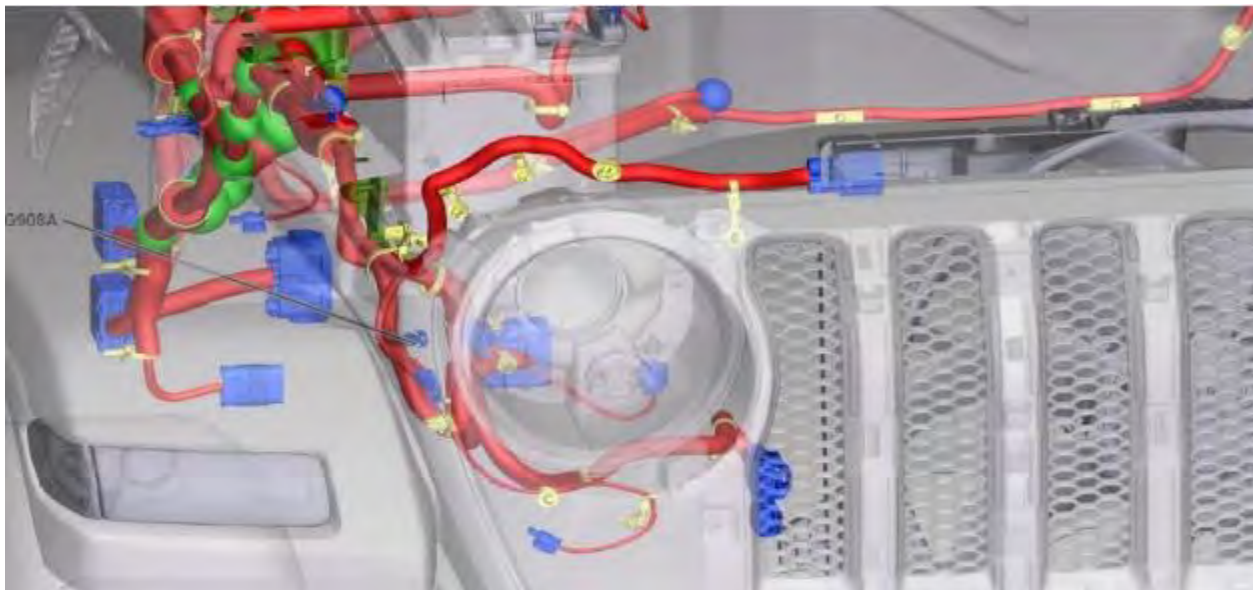
Fig 1. G908A location.

Discussion: The customer may experience a lack of power steering assist. Diagnostic trouble code (DTC) U0131 - Lost Communication With Electric Power Steering Control Module may be present. This may be caused by the ground wire not being fully welded/secured to the ground eyelet.

Diagnosis: Inspect the G908A ground located behind the passenger side headlight. Determine if the ground eyelet is properly secured to the ground wire. Check if the eyelet from the power steering ground is bent. If it is, carefully bend it back straight (Fig. 2).

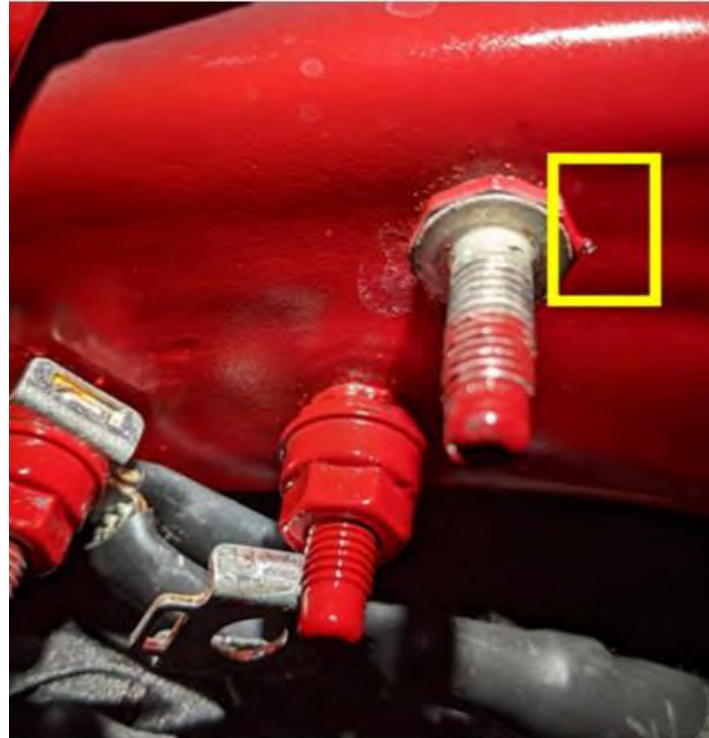
Fig 3. Weld slag to be filed or ground down.

Using a wire brush, file and emery cloth as needed, clean the top weld stud thoroughly from any impurities that can cause the eyelet not to make flat contact (dirt, paint, glue, weld slag). Refer to Fig 3. Reconnect the ground wire and torque to 15 N-m (11 Ft-Lbs.).

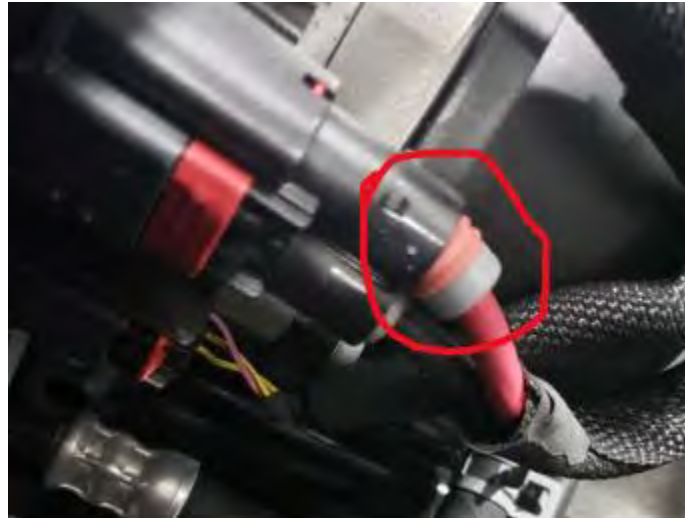
Example Of Pin Push Out.

Using a multimeter verify power and ground at the EHPS C1 connector. C2 connector has pins for CAN communication and Ignition Run Start. Inspect each for problems including pin pushout and harness routing. Repair as needed.
