**NUMBER:** 08-003-21  
**GROUP:** 08 - Electrical  
**DATE:** January 9, 2021

Improved Steering Feel

This bulletin involves replacing the steering gear and updating the Electric Hydraulic Power Steering (EHPS) software, checking sales codes and performing vehicle reconfig, if required.

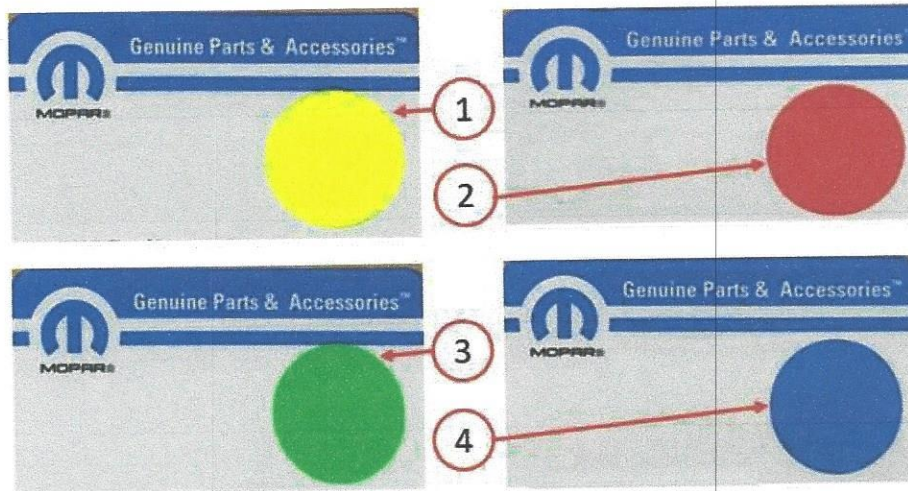
Fig. 1

**The Steering Gear Parts Label Has A Color Dot On It To Help Confirm The Correct Steering Gear Was Ordered**

- 1 - Yellow Dot, 68507576AA (JT Left Hand Drive (LHD))
- 2 - Red Dot, 68507569AA (JL 4 Door LHD, W/O EXJ 3.0 Diesel)
- 3 - Green Dot, 68507574AA (JL 4 Door LHD, With EXJ 3.0 Diesel)
- 4 - Blue Dot, 68507571AA (JL 2 Door LHD)
