# SAFETY RECALL

## Electric Hydraulic Power Steering Pump

Reference: 21D / NHTSA 26V-363

2021-2025 (JL) Jeep Wrangler

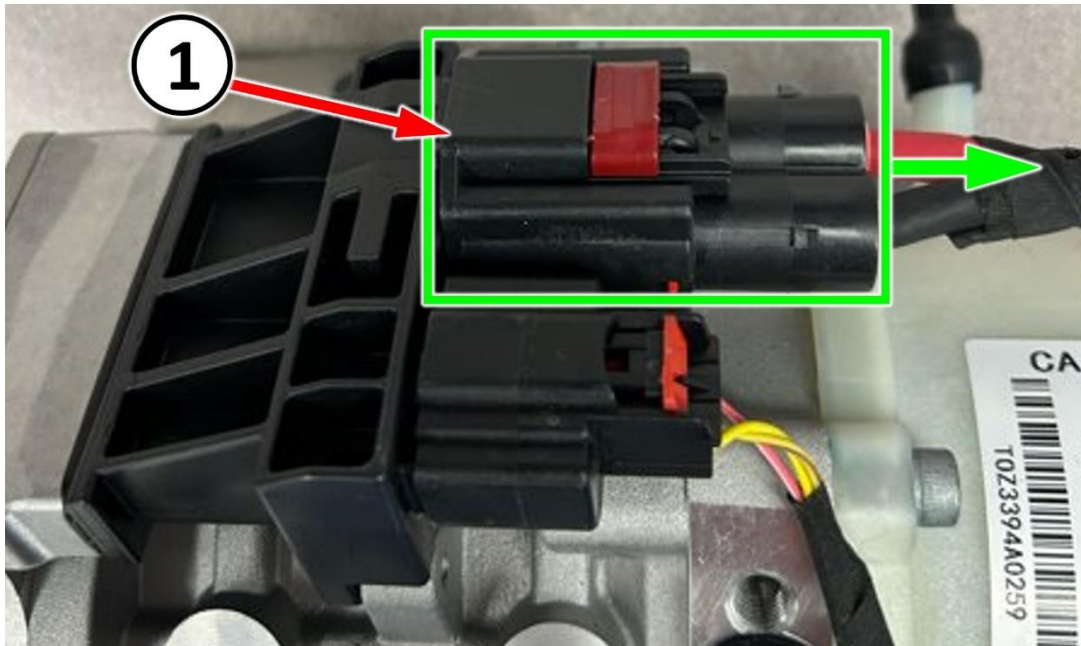
**Figure A2 – EHPS Electrical Connector Pull Test**

- b. Grasp the EHPS connector ONLY (not the wires) and pull to determine if it is securely connected to the EHPS pump. If connector releases, take photos to attach to repair claim. If connector does not detach, push on connector to ensure it is fully seated (Figure A2).

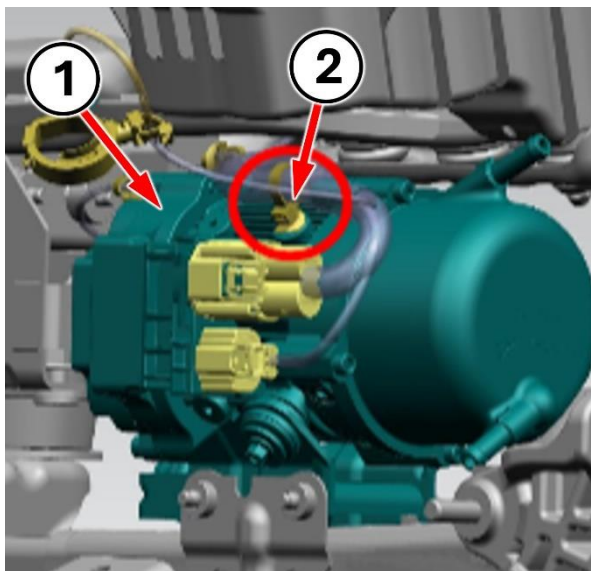
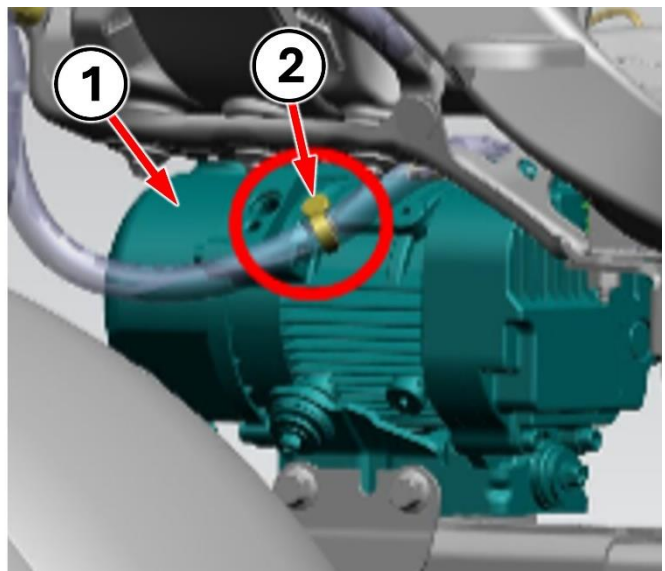
**Figure A4 – Power Steering Pump Wire Harness Routing and Clipping**

12. Were any issues found with EHPS connector or harness connections to the pump or DTC U0131 present?

- **YES:** Power steering pump replacement and wire harness overlay installation will be required. Continue with the service procedure.
- **NO:** If no issues are found with EHPS electrical connection, ensure wire harness is routed and secured properly (Figure A4). Reinstall the air cleaner body and clean air hose or air cleaner resonator depending on engine.
  - **DealerCONNECT/ Service Library under: Service Info> 09 – Engine / Air Intake System / BODY, Air Cleaner / Installation.**
  - **DealerCONNECT/ Service Library under: Service Info> 09 – Engine / Air Intake System / HOSE, Clean Air / Installation or 09 - Engine, 3.6L / Air Intake System / RESONATOR, Air Cleaner / Installation.**
  - Inspection is complete. Return the vehicle to the customer.

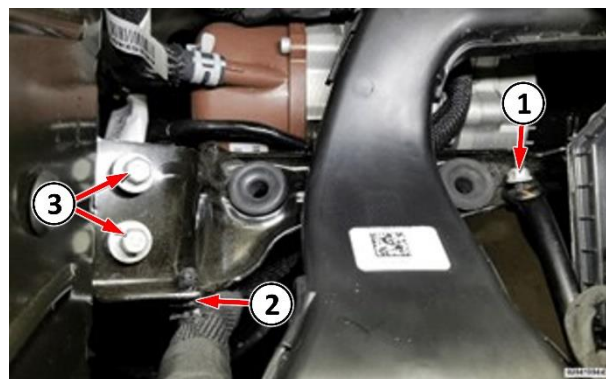
**Figure A5 – Electrical Connectors**

17. Disengage any wire harness routing retainers from the bracket as applicable depending on engine configuration (Figure A5).

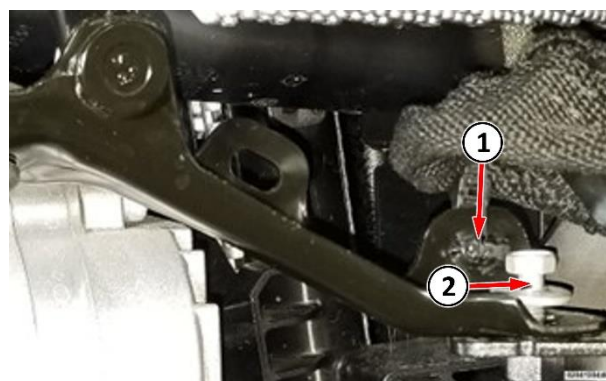
**Figure A6 – Electrical Connectors**

21. remove the air cleaner bracket (Figure A6).

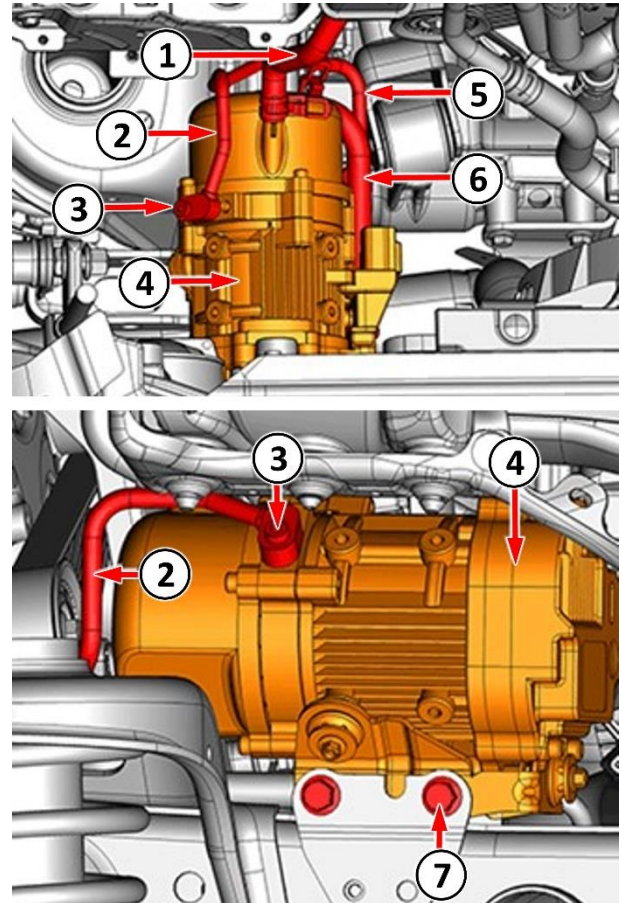
**Figure A9 – EHPS Pump**

29. With the hose clamp released, disconnect the supply hose from the EHPS pump and position the hose end higher than the power steering pump reservoir to prevent leaking while disconnected (Figure A9).

30. Remove the EHPS pump from the vehicle and set aside for return for analysis (Figure A9).

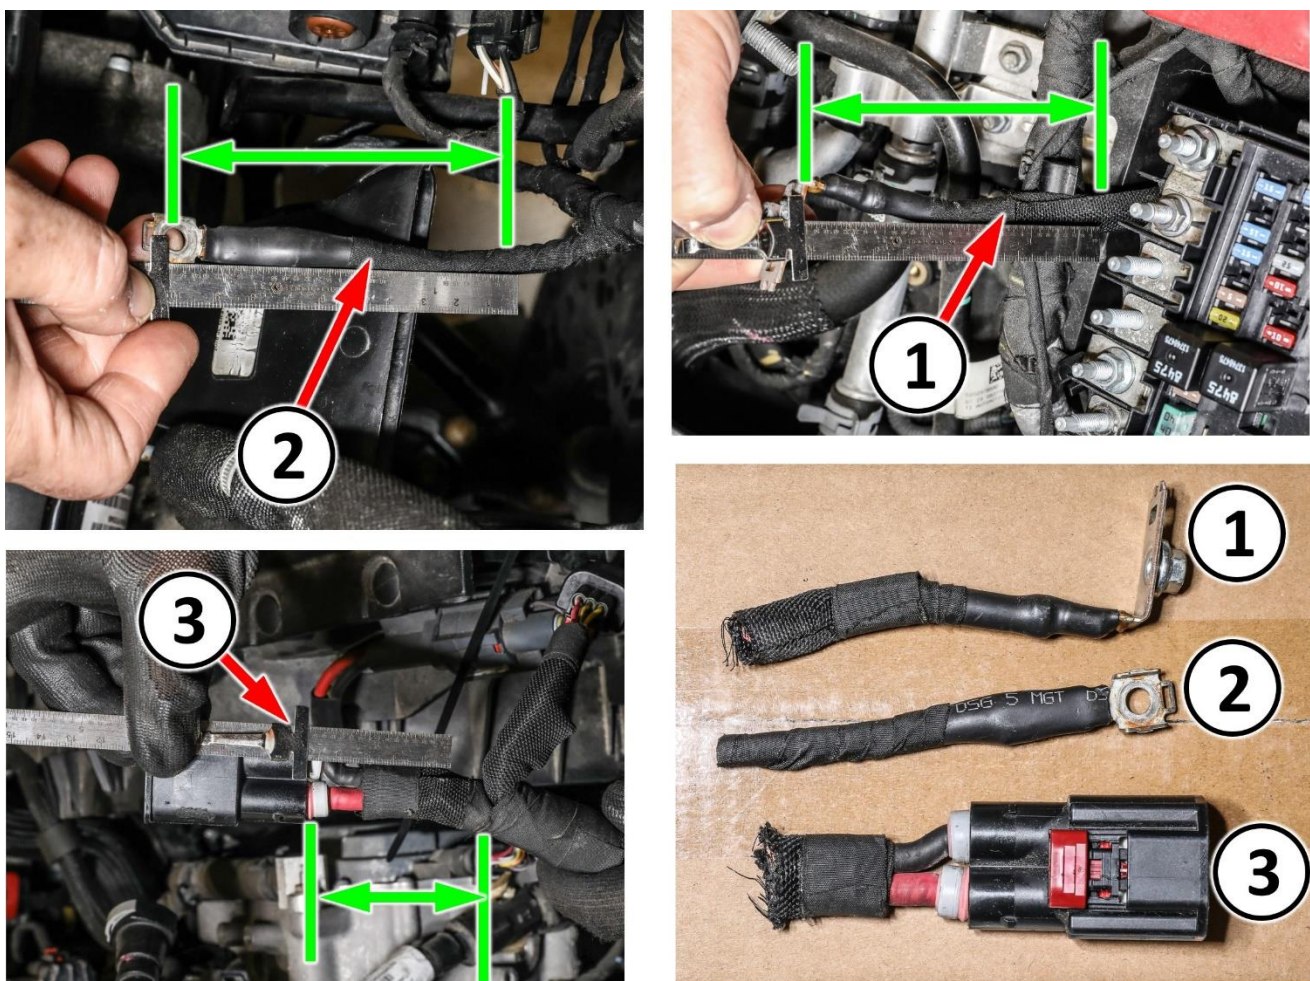
**Figure A12 – Remove EHPS Wire Harness Terminals**

37. After verification, cut EHPS power supply eyelet D6630J approximately 4 inches behind eyelet 90-degree bend and set aside for return for analysis (Figure A12).
38. After verification, cut ground eyelet G908A approximately 4 inches behind center of eyelet hole and set aside for return for analysis (Figure A12).
39. Cut 2way EHPS connector D2704A approximately 2 inches behind connector body taking special care not to cut through 3way connector D2704B circuits. Set aside for return for analysis (Figure A12).

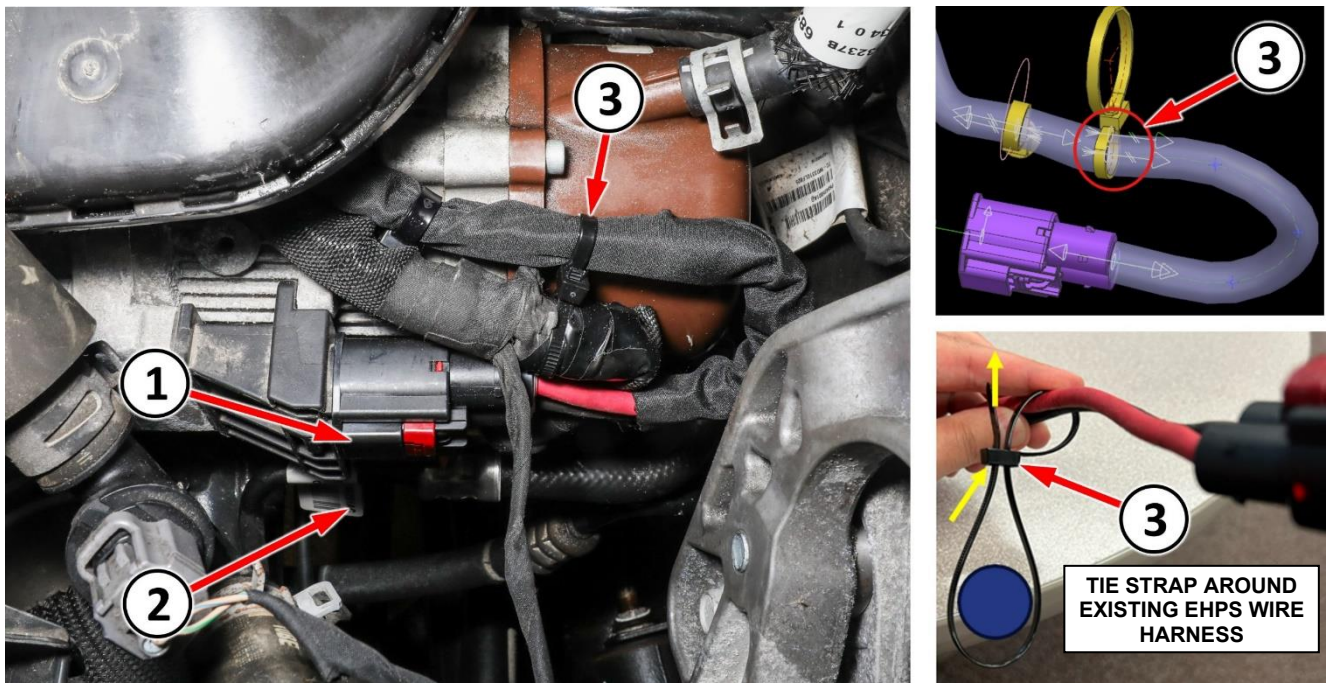
**Figure A18 – Power Steering Pump Wire Harness Routing and Clipping**

50. Connect the electrical connectors to the EHPS pump then engage the red CPA connector latch in locked position (Figure A18). Verify connection with Push-Pull-Push on connector, not on circuits.
51. Secure overlay to existing EHPS dash wiring bundle with double tie strap clip while making sure overlay is not in direct contact with sharp edges.

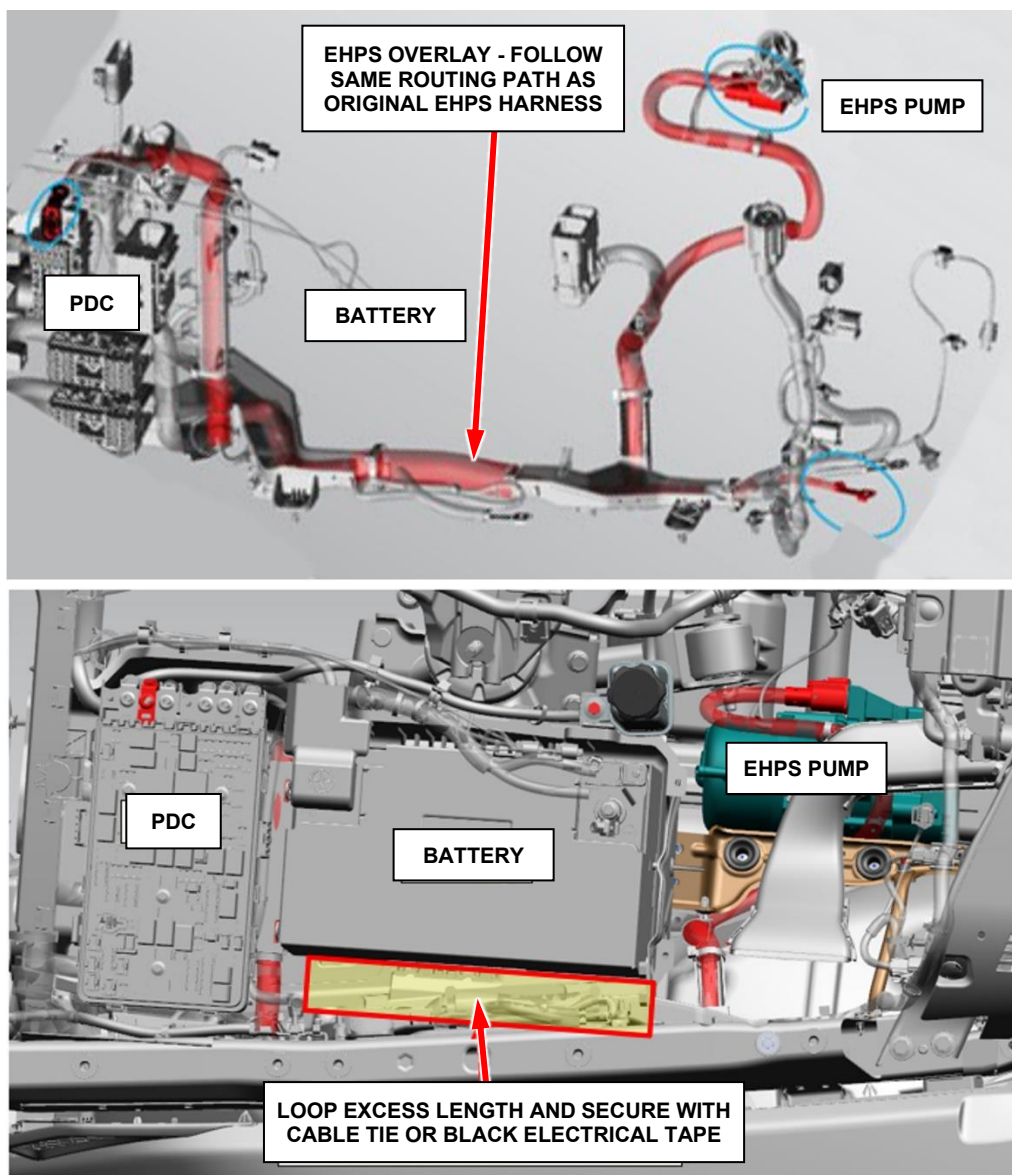
**Figure A19 – Power Steering Pump Wire Harness Overlay Routing**

52. Route remainder of EHPS overlay harness along existing dash harness bundle routing, securing double tie strap clips to existing dash harness wiring bundle. Make sure overlay is not in direct contact with sharp edges. Reference routing pictures below (Figure A19).
53. Loop and secure with cable tie or black electrical any excess overlay jumper wire length outboard of battery.

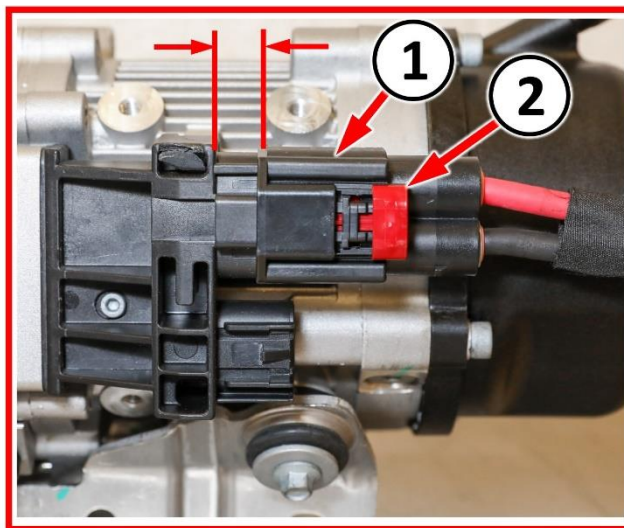
- a. Visually verify Electric Hydraulic Power Steering (EHPS) connector is fully mated to the pump interface with CPA fully engaged on the connector latch. If electrical connector is not fully mated or CPA is not engaged, take photos to attach to repair claim (Figure B2).

**Electrical Connector and CPA  
Fully Engaged, No Gap**

**Electrical Connector and/or CPA  
Not Fully Engaged, Gap Observed**

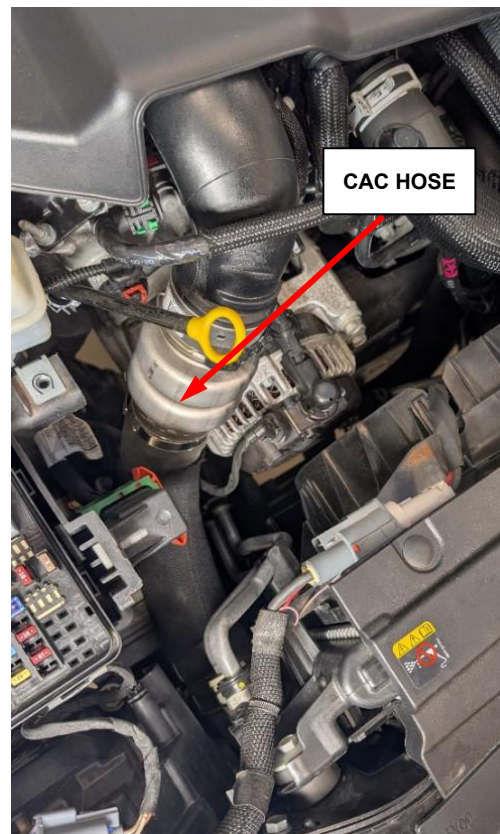
**Figure B6 – CAC Hose**

13. (3.0L Only) Remove the Charge Air Cooler (CAC) Hose (Figure B6). Refer to the detailed service procedures available in DealerCONNECT/ Service Library under: Service Info> 09 - Engine, 3.0L Turbo Diesel / Turbocharger System / COOLER and HOSES, Charge Air / Removal and Installation.

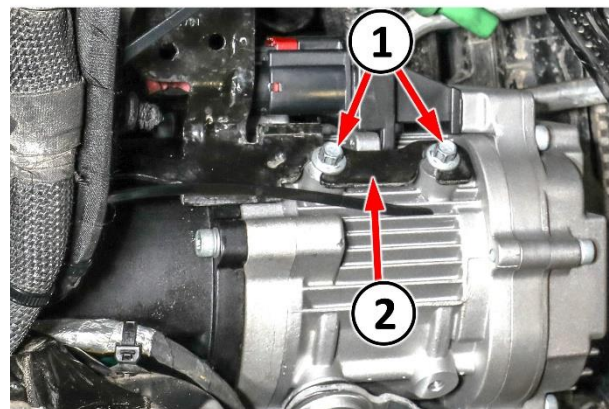
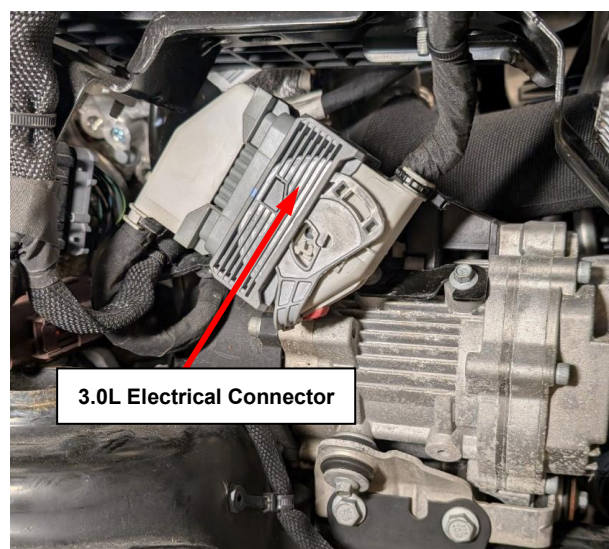
**Figure B11 – Wire Harness Bracket**

**NOTE:** For 3.0L vehicles, disconnect the electrical harness connector to gain bolt access (lower image in Figure B11).

1 - Bolts

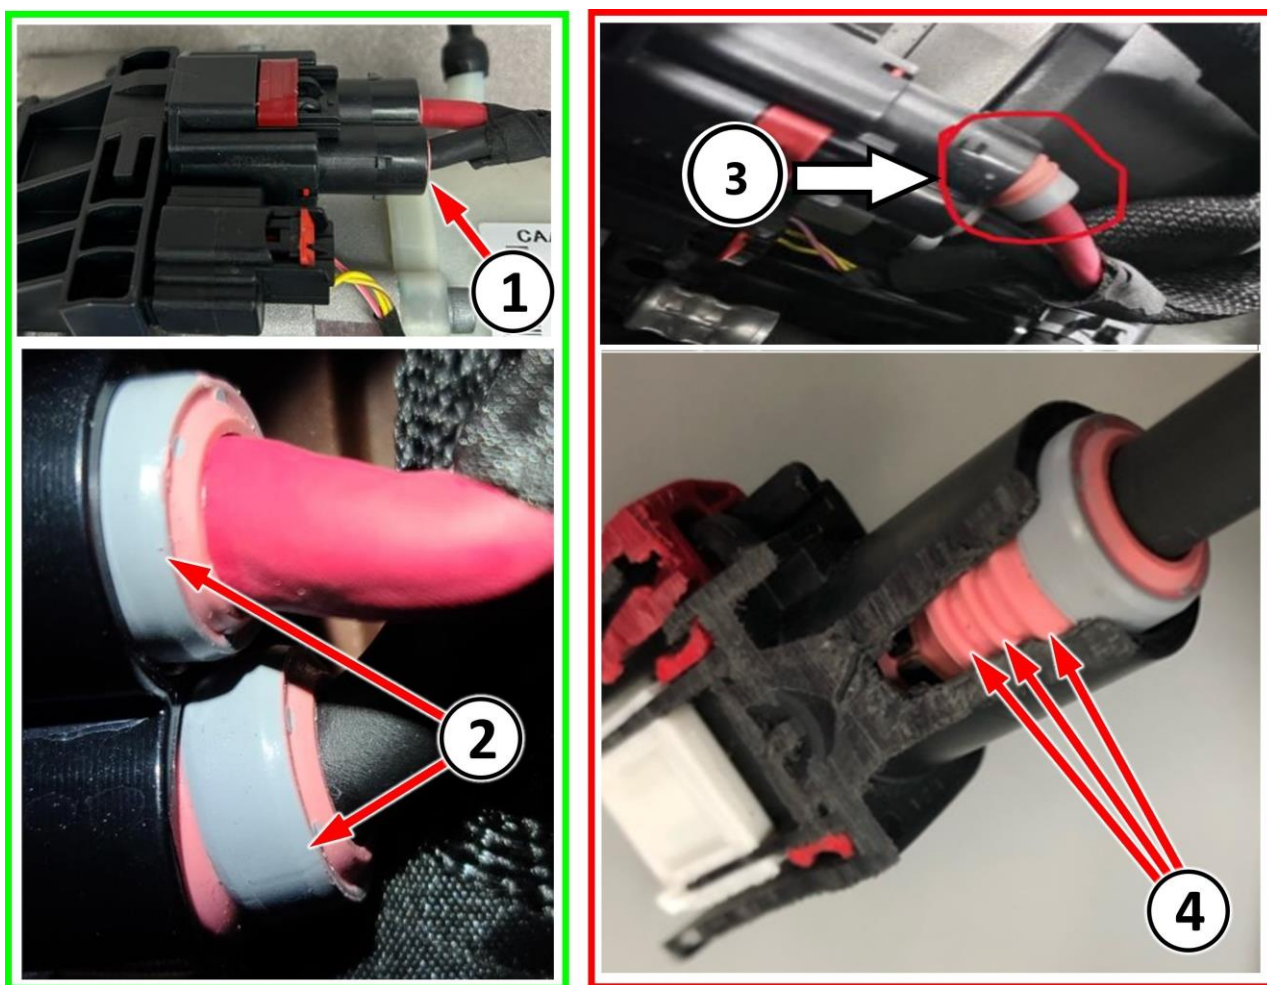
- c. Inspect the wire harness for any wires that are not fully inserted into the connector as shown in the following images. If the sealing ribs are exposed, take photos to attach to repair claim (Figure C3).
- d. Visually inspect for any visible damage to harness bundle and EHPS connector. If damage is observed, take photos to attach to repair claim.

Correctly Inserted Terminals - OK

Ribs Exposed - Not OK Condition
